Floataction tank associated *Pseudomonas aeruginosa* infection

Abstract: Floataction tank water contains a high concentration of magnesium sulfate (MgSO_4), which should be unfavorable to most microorganisms that are not salt tolerant. The high salt concentration also means that users of floataction tanks are more likely to shower after floating and are less likely to float with open sores, get water in their eyes, or ingest the floataction tank water. In addition, the number of daily users is relatively stable. However, despite these factors, pathogens commonly associated with pool or hot tub use can still be found in floataction tanks. A clinical case of *Pseudomonas aeruginosa* infection associated with exposure to a floataction tank was investigated by Vancouver Coastal Health. The investigation resulted in the issuance of a closure order to the operator of the facility. A clinical specimen obtained from the complainant and a water sample from the implicated floataction tank both tested positive for *Pseudomonas aeruginosa*, although, the isolates were markedly different. The possible explanations for this laboratory outcome are presented. This case study illustrates that a di

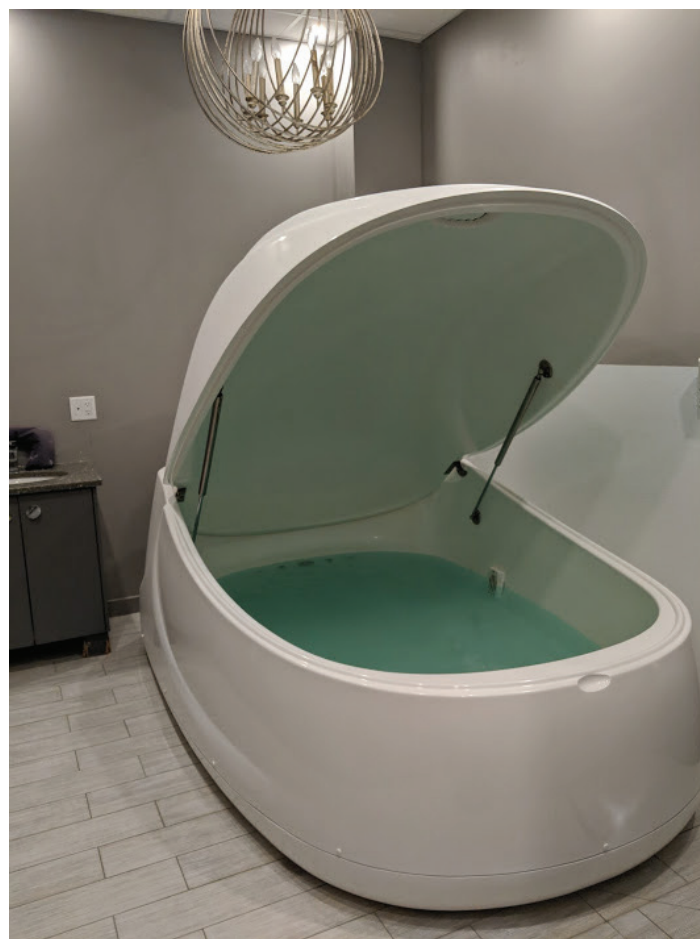
Fig. 1: Floatation Tank. Photo taken by K. Rehbein Oct 2018.
